# Manhole Inspection Summary

Manhole # S29S1\_001MH

Insp Date: **4/9/09 12:02 PM**

**Location** Address: **3430 Spelman Rd.**

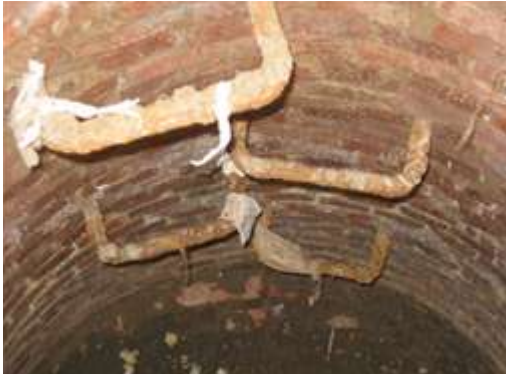
steps

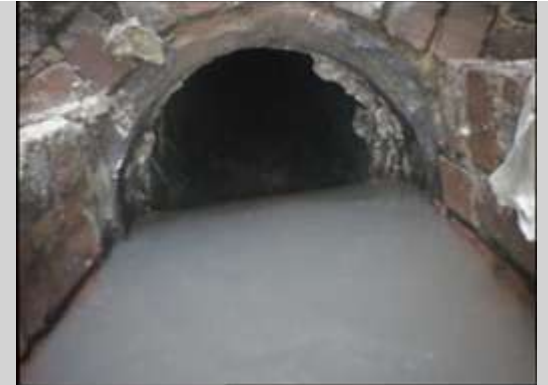
12 O'Clock Outflow

15 in. Circular Gravity Sewer  
Pipe Out @ 12 O'Clock

Pipe Height: **15.6** (in.) Rod and Bar (Angled)  
Pipe Material: **Clay** ☐ Pipe Lined  
Invert Depth: **9.60** (ft.) Flow Characteristics: **Fast**  
Deposits: ☒ None ☐ Mud ☐ Sludge ☐ Debris ☐ Grease  
Silt Depth: (in.) Deposits Extent:  
Infiltration: **None** Pipe Seal Cond: **Sound**

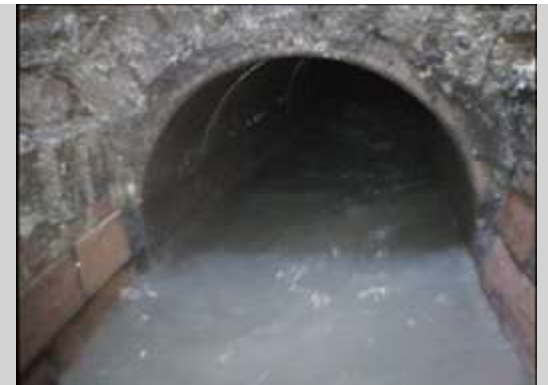
6 O'Clock Inflow

15 in. Circular Gravity Sewer  
Pipe In @ 6 O'Clock

Pipe Height: **16.8** (in.) Rod and Bar (Angled)  
Pipe Material: **Clay** ☐ Pipe Lined  
Invert Depth: **9.60** (ft.) Flow Characteristics: **Fast**  
Deposits: ☒ None ☐ Mud ☐ Sludge ☐ Debris ☐ Grease  
Silt Depth: (in.) Deposits Extent:  
Infiltration: **None** Pipe Seal Cond: **Sound**

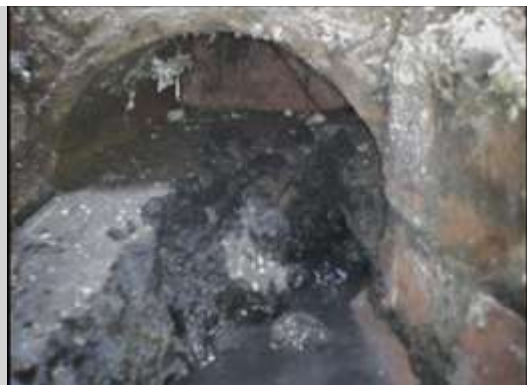
9 O'Clock Inflow

10 in. Circular Gravity Sewer  
Pipe In @ 9 O'Clock

plugged

Connects To: **Stub connection / abandoned**
